TECH ARTICLE # T001

Shudder – EA to EL Falcon – Preventing Shudder

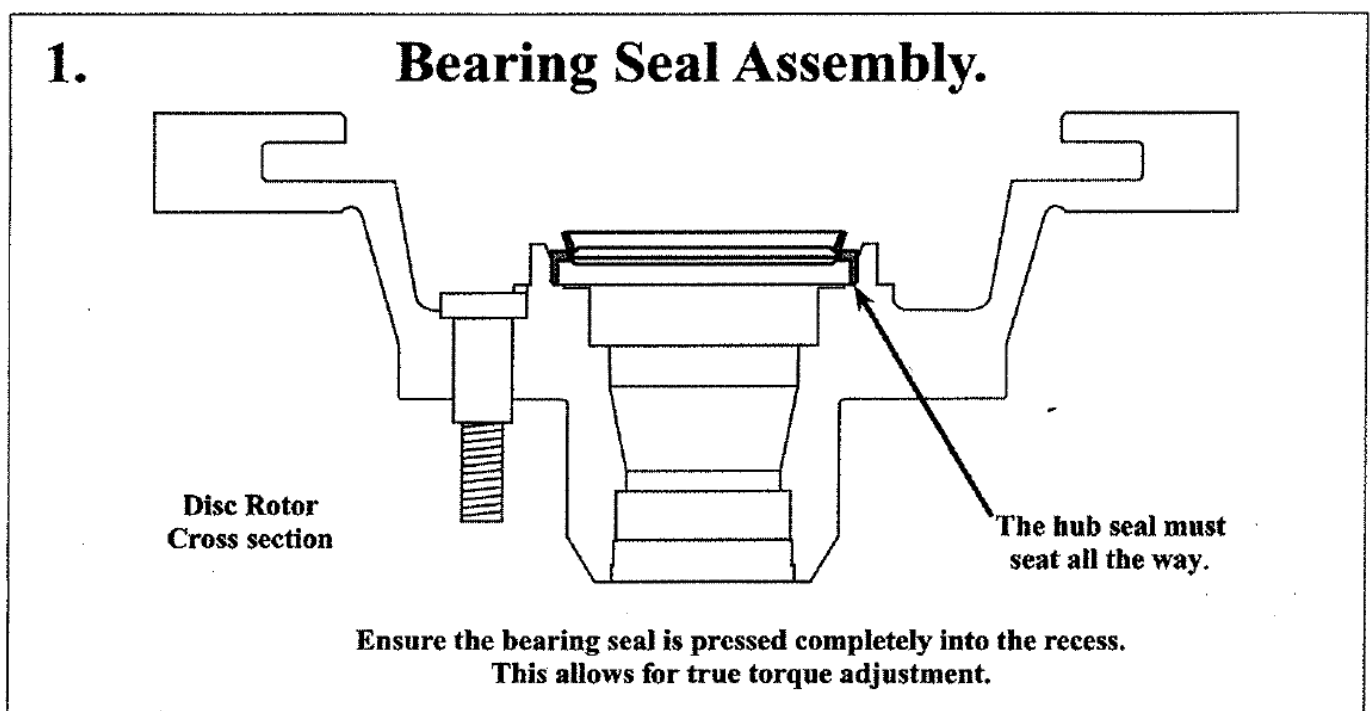
The seal must be inserted all the way to the bottom of the bore (refer to diagram 1).

If it does not go all the way in, when attempting to adjust the bearings, the seal presses against the end of the stub axle and therefore you cannot adjust the bearing correctly.

Because of the design of the rotor, it tends to lean over towards the hub and if the bearings are not adjusted correctly then built-in run-out will occur.
