TECH ARTICLE # T018

DISC ROTOR NOISE - DBA 5000 SERIES CLICKING NOISE

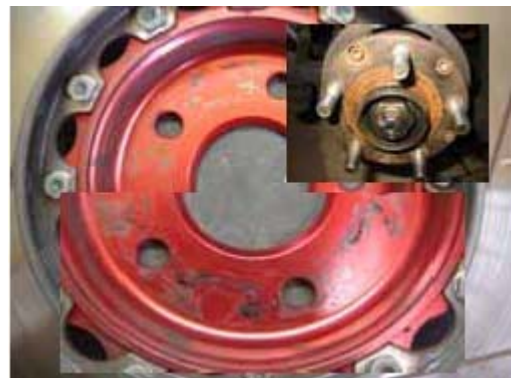
This movement shows as slight galling on the face of the hat which is sometimes amplified as a 'clicking' sound.

To minimize noise from the 5000 series disc rotors it is very important that the aluminium hat/bell is clamped evenly between the hub and wheel faces. If the hub face is not cleaned thoroughly this will cause the disc rotor to be mounted with run out which can cause DTV (Disc Thickness Variation) over a short period of time resulting in brake shudder.

This can also cause the hat/bell to be clamped unevenly which can allow very slight movement between the hat/bell and the wheel/hub faces. If the hub is cleaned and the wheel mounting face is not this can cause very slight movement between the wheel and the hat/bell.
